ANNUAL REPORT FOR 2005

Michael's Branch Mitigation Site
Alamance County
TIP No. U-3110A

Prepared By:
Natural Environment Unit & Roadside Environmental Unit
North Carolina Department of Transportation
December 2005

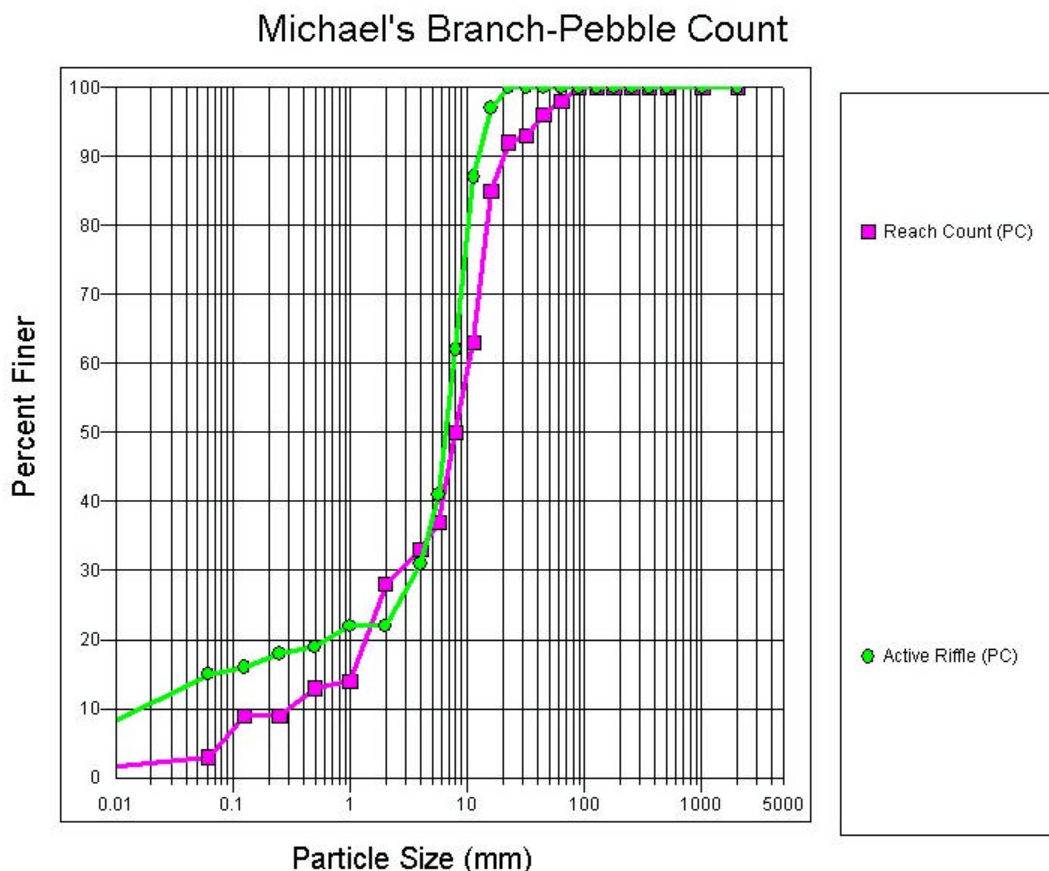
Pebble counts were also taken at each cross section as a means to determine the bed material at each cross section location. However, only pebble counts taken at riffle sections will be utilized to classify the stream. No existing data was available for Michael's Branch. The pebble counts taken during the Year 2005 monitoring period noted that the D_{50} (50 percent of the sampled population is equal to or finer than the representative particle diameter) for the riffle sections of Michael's Branch was approximately 6.69mm, which is indicative of a gravel-bed stream.

A chart depicting the particle size distributions for Michael's Branch for the Year 2005 is presented below.

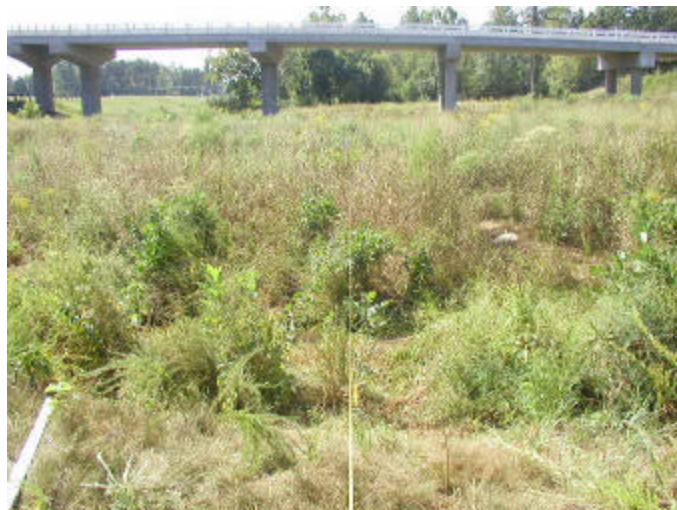
Cross-Section #1 (Riffle) Abbreviated Morphological Summary

2005	2007	2009
Bankfull Cross Sectional Area (ft ²)	29.7		
Maximum Bankfull Depth (ft)	2.22		
Width of the Floodprone Area (ft)	37.5		
Bankfull Mean Depth (ft)	1.2		
Width/Depth Ratio	18.14		
Entrenchment Ratio	1.72		
Bankfull Width (ft)	21.8

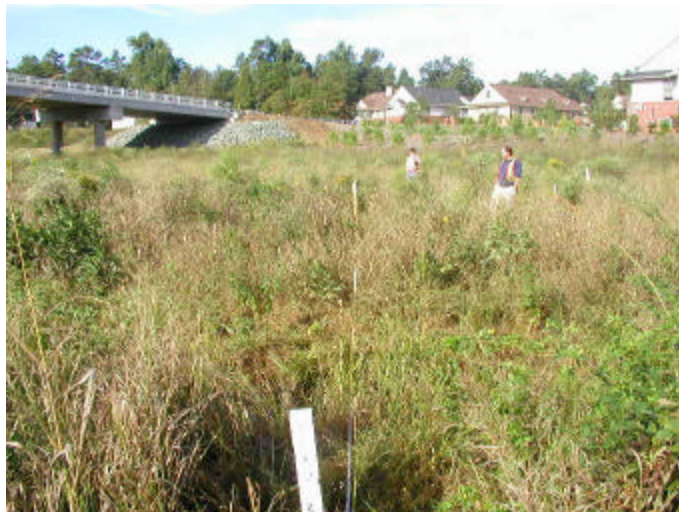
Pool Cross Section #2

2005	2007	2009
Bankfull Cross Sectional Area (ft²)	26.69		
Maximum Bankfull Depth (ft)	3.28		
Bankfull Mean Depth (ft)	1.32		
Bankfull Width (ft)	20.28
